**RE: Water Code Section 13267 Technical Report on Erosion of Mercury Mining  
Waste, Guadalupe Recycling and Disposal Facility - 15999 Guadalupe  
Mines Road, San Jose, California**

**RE: Water Code Section 13267 Technical Report on Erosion of Mercury Mining Wastes  
at Guadalupe Mercury Mine, Santa Clara County  
Guadalupe Recycling and Disposal Facility, San Jose, CA**

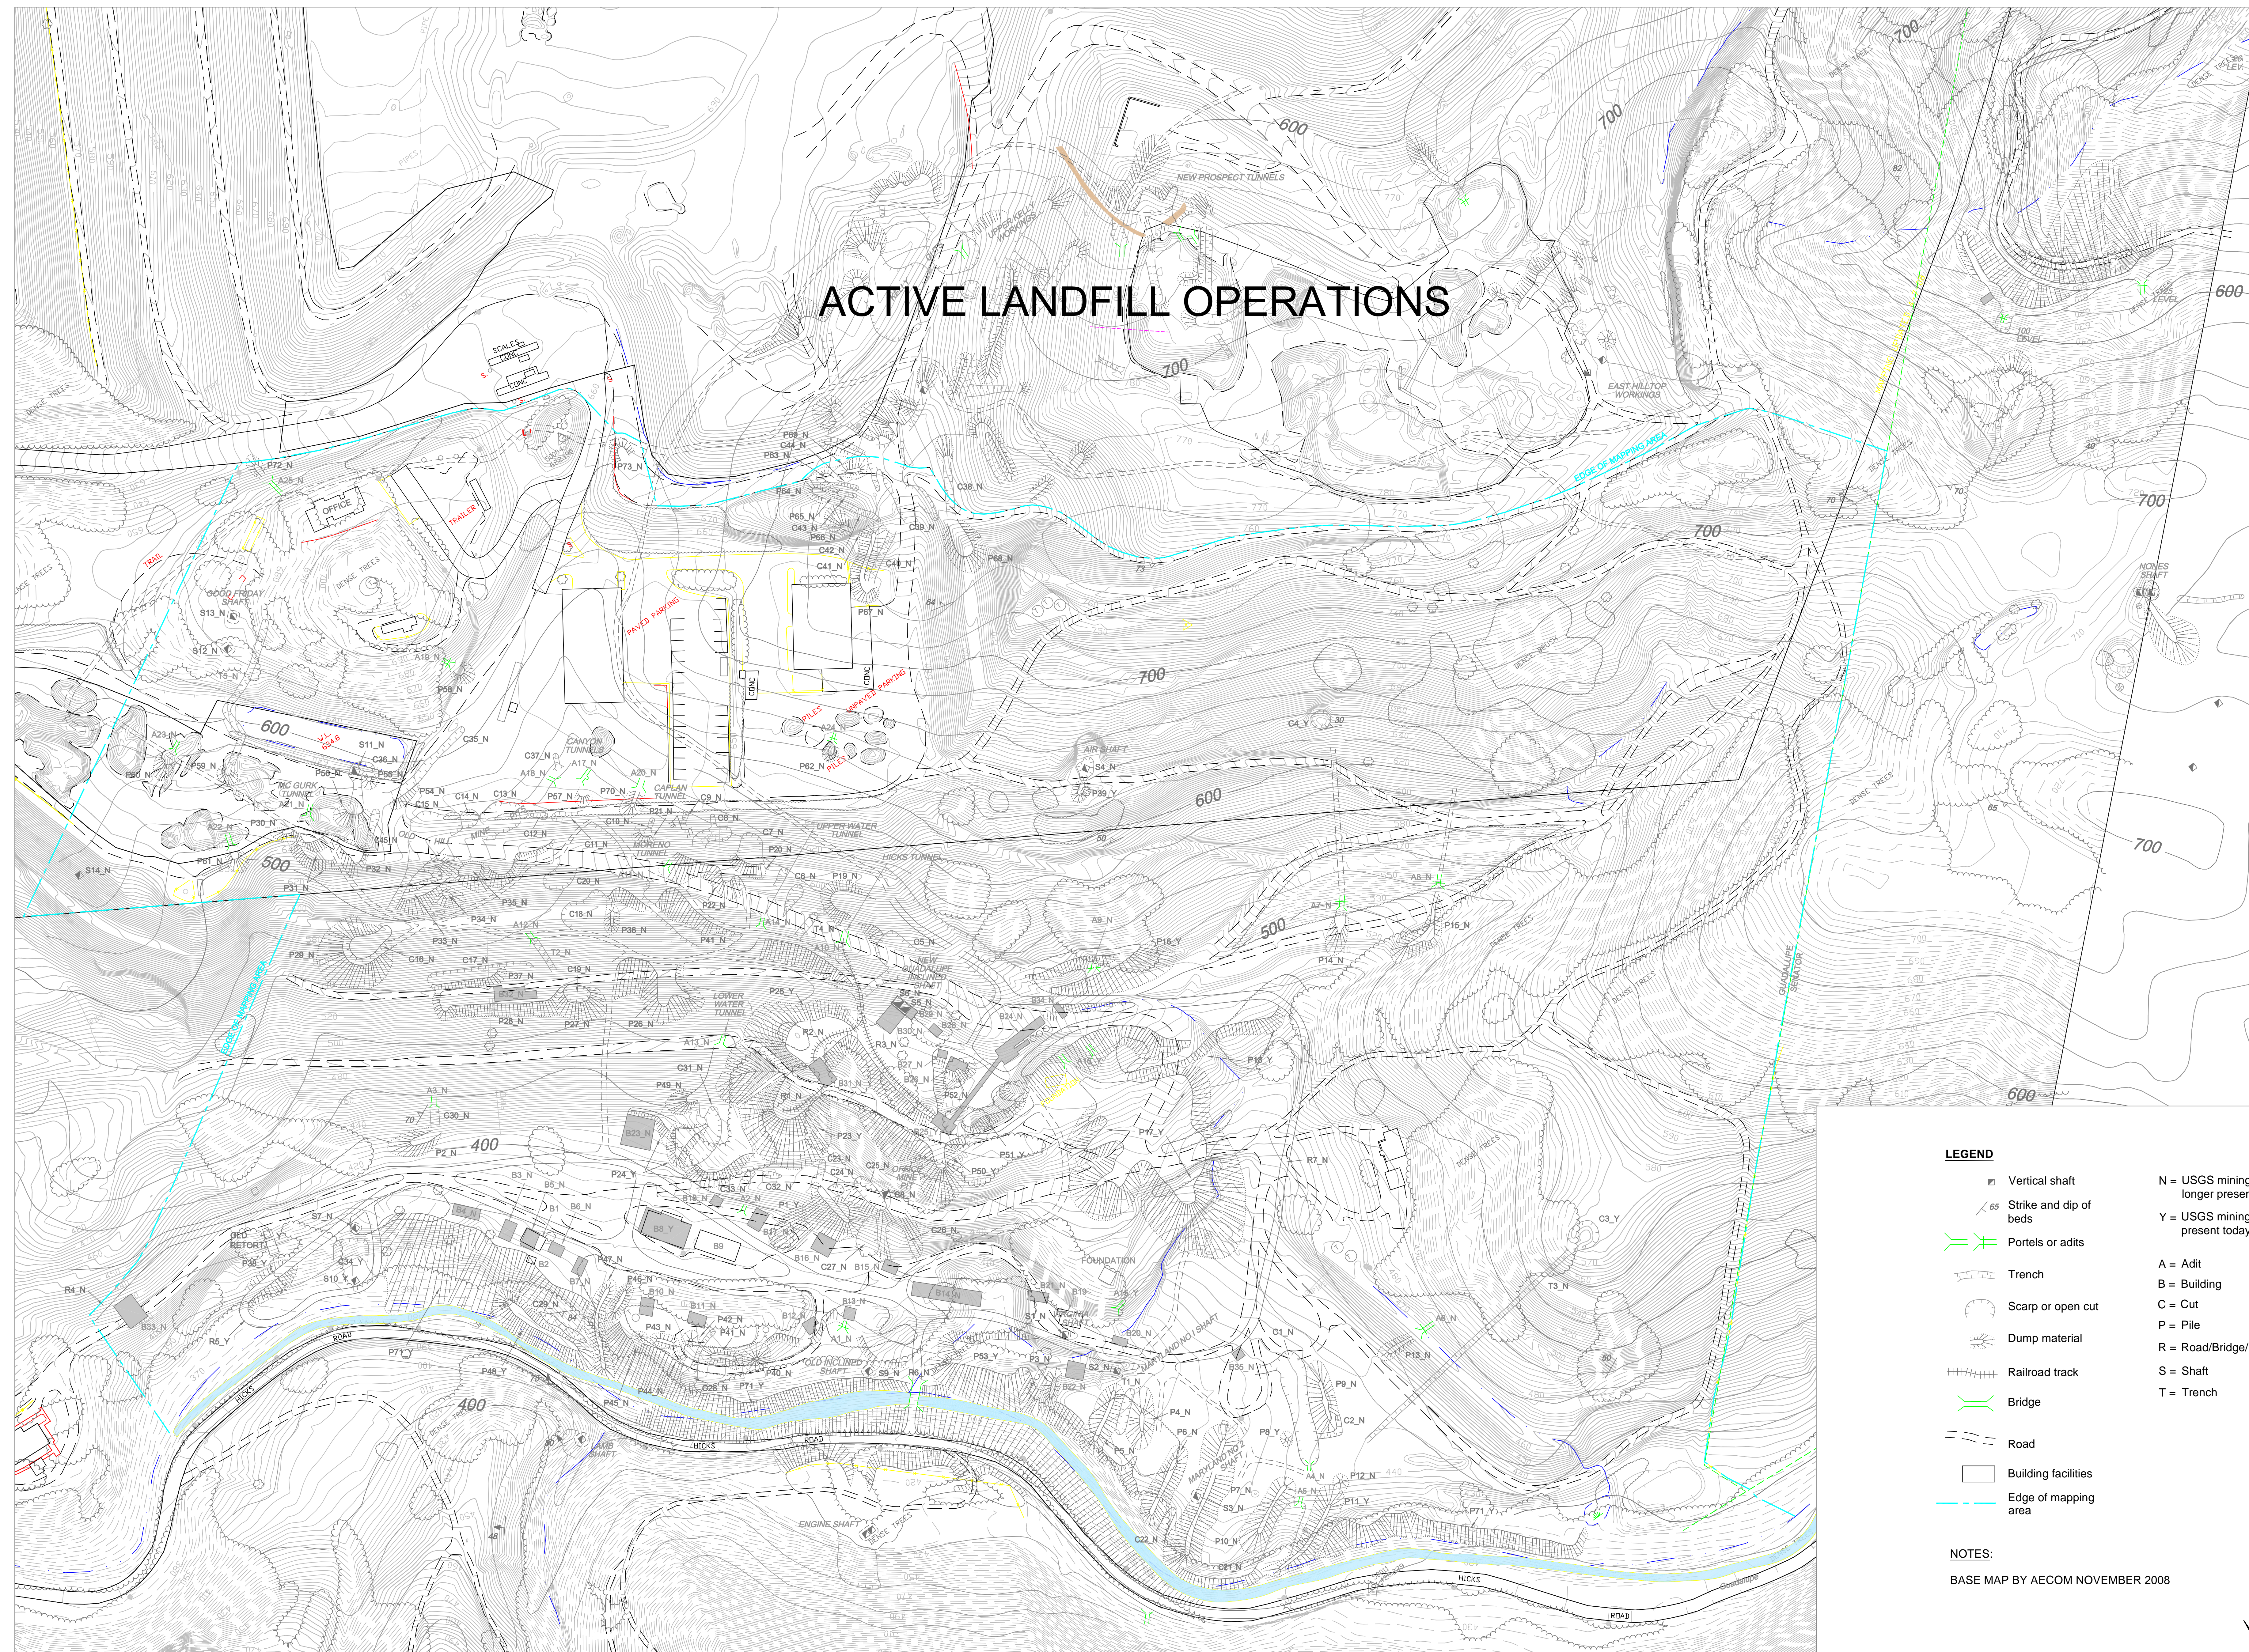
In August 2010, Stantec, at the direction of GRDF, conducted an independent field check of the map prepared by AECOM based on a compilation of field observations made by Stantec since March 2009. Where detailed field inspection yielded an interpretation which differed from that indicated on the map prepared by AECOM, the map was revised to reflect Stantec's observations. It should be noted that the former mine site has been extensively re-graded and the passage of time and establishment of vegetation has obscured the surface expression of former mine workings and features. Very few, if any, of the mine structures and buildings mapped by the USGS remain at the site for use as reference points during current field inspection activities. Accordingly, a degree of interpretation is necessary in making a current determination regarding the presence or absence of historic mining features.

For ease of presentation on the attached map (Figure 3), the mining features depicted on Plate 14 of the 1964 USGS report have been coded with either "Y" (Yes-Present) or "N" (No-Absent). However, this nomenclature is likely an over-simplification of actual field conditions. After as long as 65 years since the site was mapped by the USGS, none of the features classified as present can be considered in the same condition as originally mapped. Mine openings, such as adits and shafts denoted on the map as present, are actually partially plugged, flooded, or collapsed. With respect to waste piles and dumps mapped as currently present, such features have likely been partially reworked and revegetated. Conversely, for historic mine workings mapped as no longer present, a surface expression of previous ground disturbance is commonly visible.

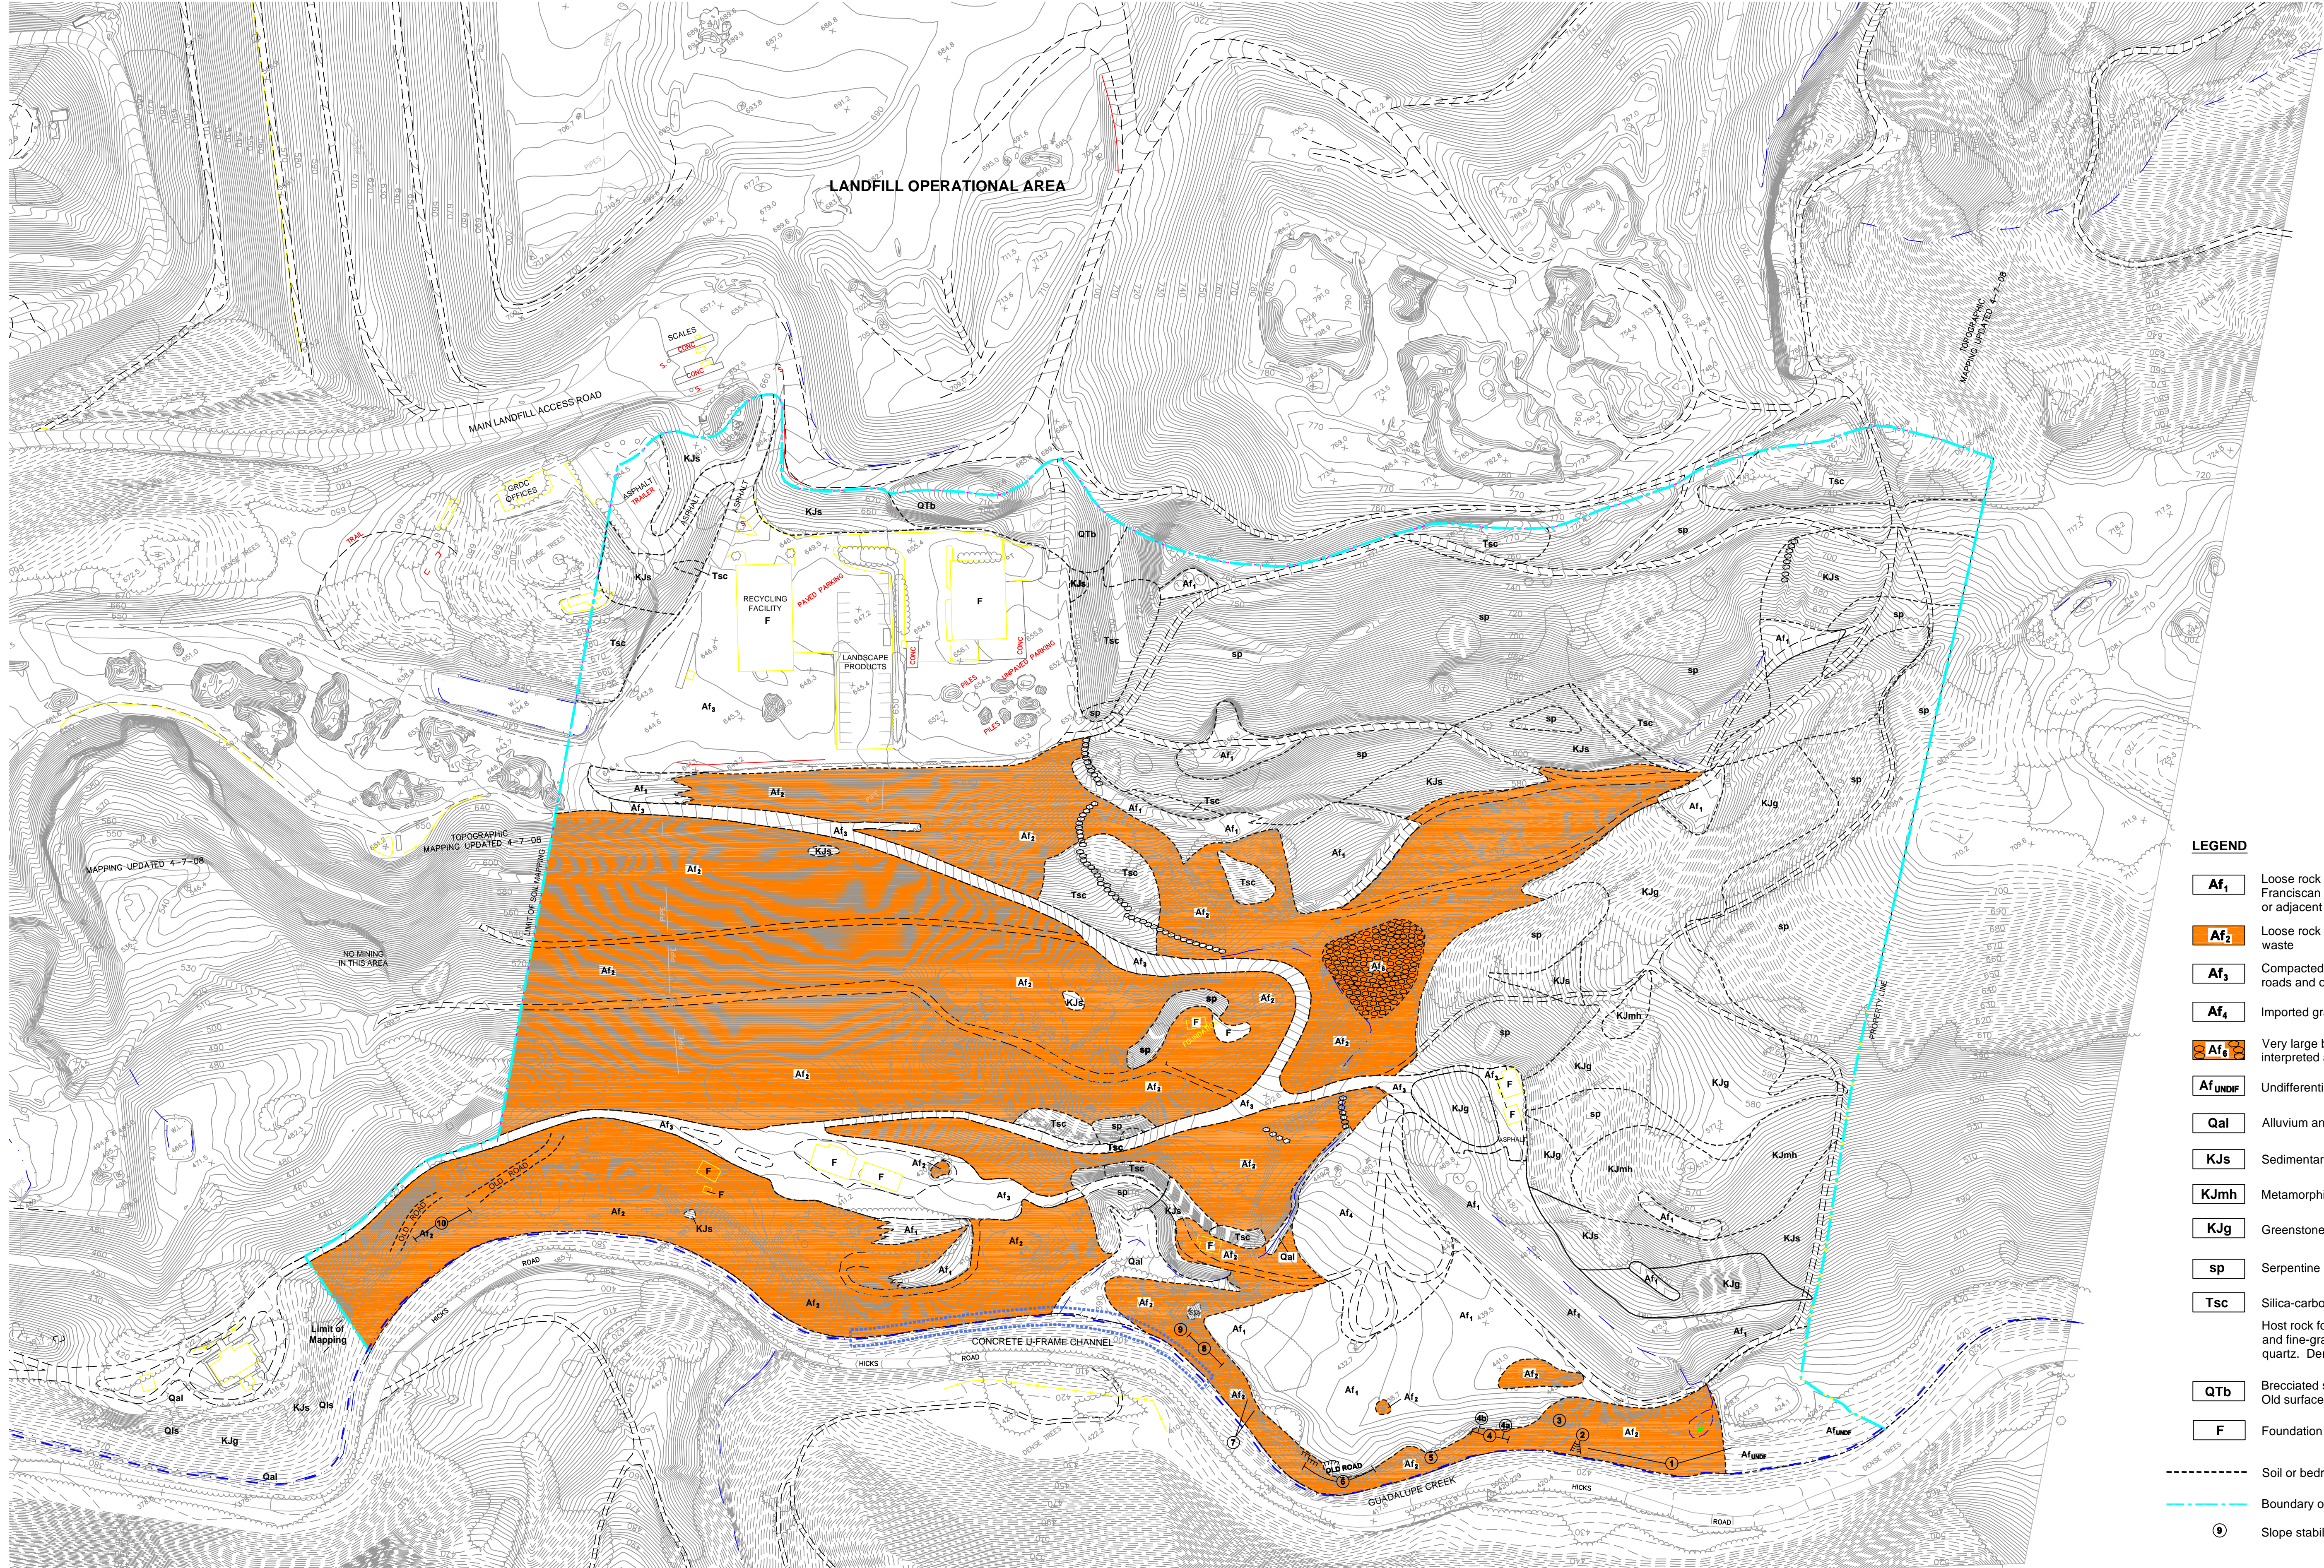
FIGURE:  
4  
DATE: 1/5/2011

Surface geology and artificial fill at the Site, as mapped by AECOM and field checked by Stantec, is shown on Figure 4. The most readily identified mining waste at the Site is silica-carbonate waste rock present as rock piles and boulders. The larger boulders of silica-carbonate rock were mapped by AECOM using the "Af<sub>6</sub>" designation shown on Figure 4. The silica-carbonate rock comprising these boulders is hard, fairly inert, and exposed primarily to subaerial weathering. Visible sulfide mineralization (e.g. pyrite, chalcopyrite) in hand samples is generally absent. Hence, the potential of these rocks to erode, where not in direct contact with surface water, is considered to be low.

The vast majority of the mining waste present consists of gravelly sand fill material dominated by silica-carbonate lithology and mapped by AECOM using the "Af<sub>2</sub>" designation shown on Figure 4. This material is interpreted to represent crushed waste rock mixed with overburden from mining activities. The overburden/waste rock is present as unconsolidated fill present along the northern bank of the Creek and on the reworked upland slopes which have been sloped and terraced for erosion control. This material, which in many areas displays soil-like properties, readily supports vegetation such as grass, clover, brush, and berry vines.

The mapped surface distribution of mining waste currently exposed is shown on Figure 4 and encompasses the waste classifications described above. Also shown on Figure 4 are the lateral boundaries of the mapping area which are formed by the active landfill operational areas to the north, the Creek to the south, legal property line to the east, and the limit of mining activity mapped by the USGS to the west.

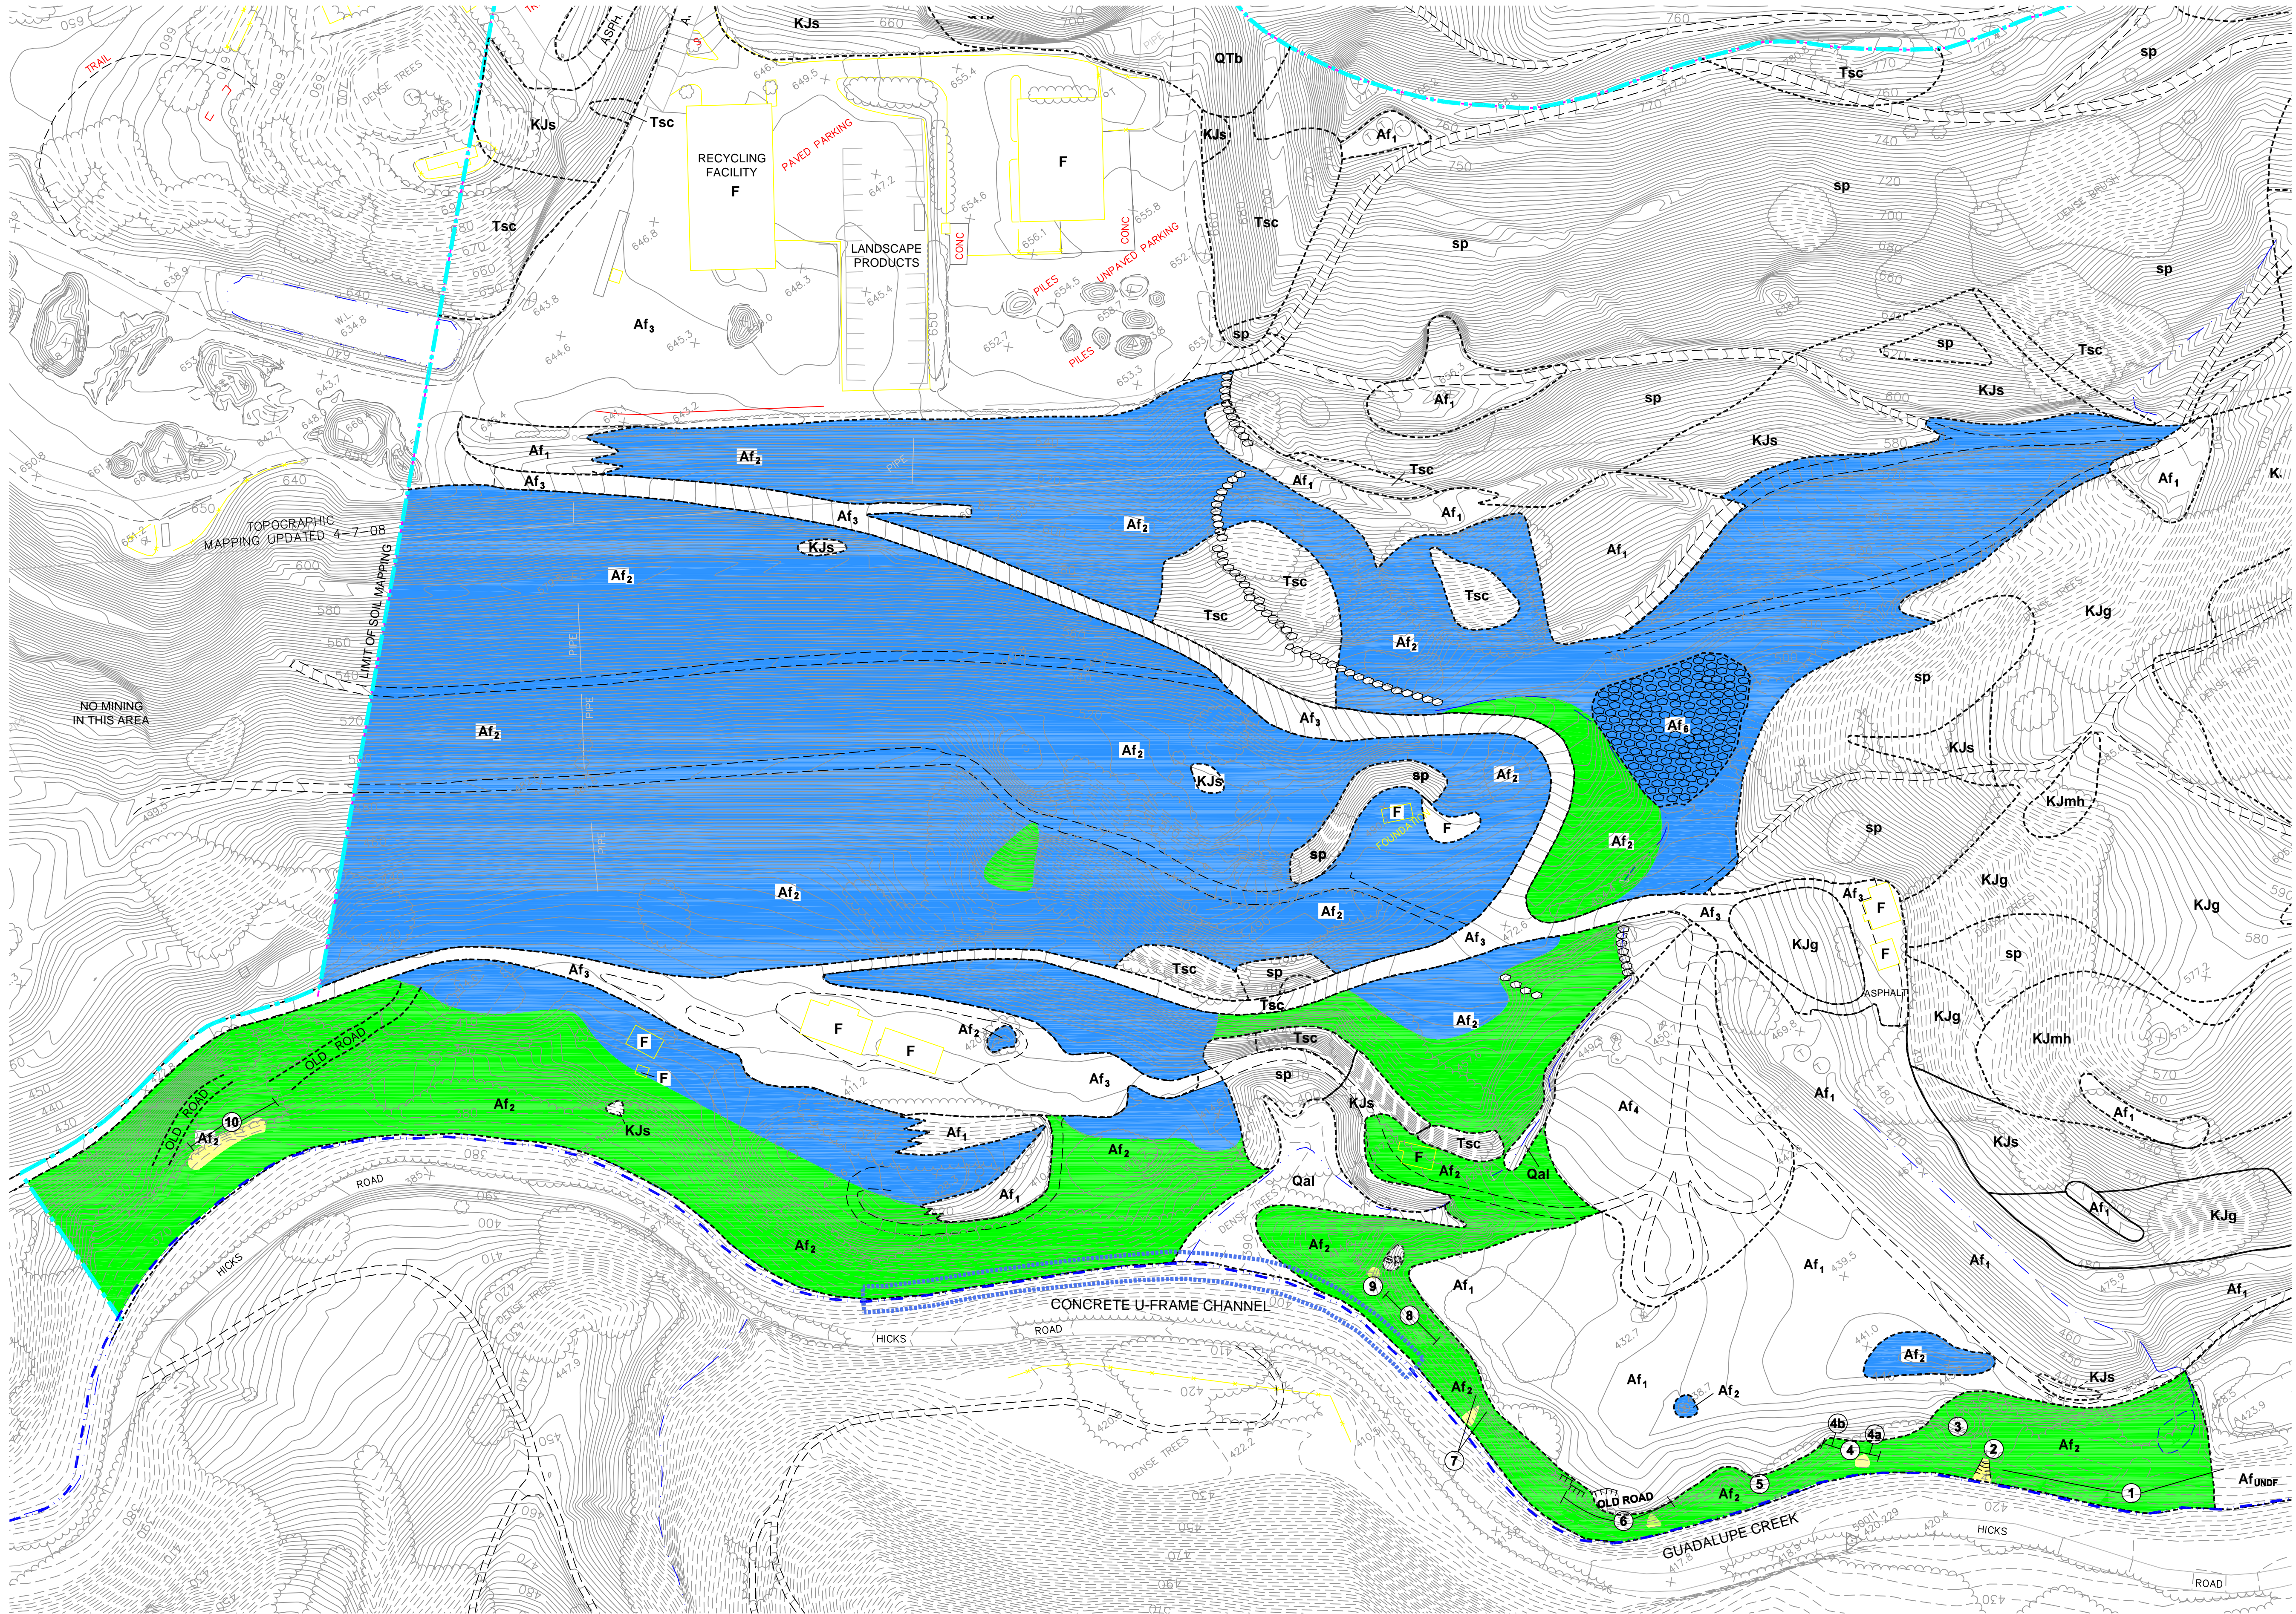
FIGURE:  
5

The potential erodibility (erosion potential) of the mining waste was ranked using the criteria suggested by Water Board staff, as shown on Figure 5. No mining waste meeting the criteria of "high" erosion potential are currently present at the Site, based on the erosion and sedimentation BMPs implemented to date. The medium-high erosion potential designation was assigned to the Phase 2 BMP areas (Area 2, vertical sections of Areas 4 and 6, Area 9, and Area 10) where exposed mining waste is susceptible to surface water transport due to vertical slopes, direct contact with runoff, and possibly, contact with Creek water during periods of high storm flows. The Phase 2 Areas BMPs implemented in October 2010 should further reduce the erosion potential at these locations.

Mining waste assigned the medium-low ranking are those areas where vegetation is well established or where BMPs have been implemented to stabilize exposed fill. However, due to the proximity of the Creek, sheetflow and surface runoff could transport mineralized sediment to surface waters. This designation was applied to the unconsolidated fill along the northern bank

of the Creek. Away from the Creek, the medium-low designation was used for mining waste slopes in close proximity to surface water conveyance channels and those exhibiting gullies.

Relatively level areas which appear stable and upland areas away from the Creek with low erosion activity were ranked as having low erosion potential. The existing Storm Water Pollution Prevention Plan (SWPPP) for the Site and current storm water conveyance and detention structures were also considered in ranking the potential erodibility of mining waste.

As included in the Section 13267 request from the Water Board, Stantec evaluated appropriate control measures necessary to stabilize actively or potentially eroding mining wastes. Detailed specifications for erosion and sedimentation controls at the Phase 1 areas near the Creek were provided in the June 2, 2009 work plan. As documented in the *Construction Completion Report*, BMPs were implemented at the Phase 1 areas prior to October 15, 2009. Specifications for interim BMPs at the Phase 2 areas were included in the September 2010 *Work Plan Addendum* and field implementation was completed in October 2010. No new areas of exposed soils or mass wasting near the Creek have been identified to date.

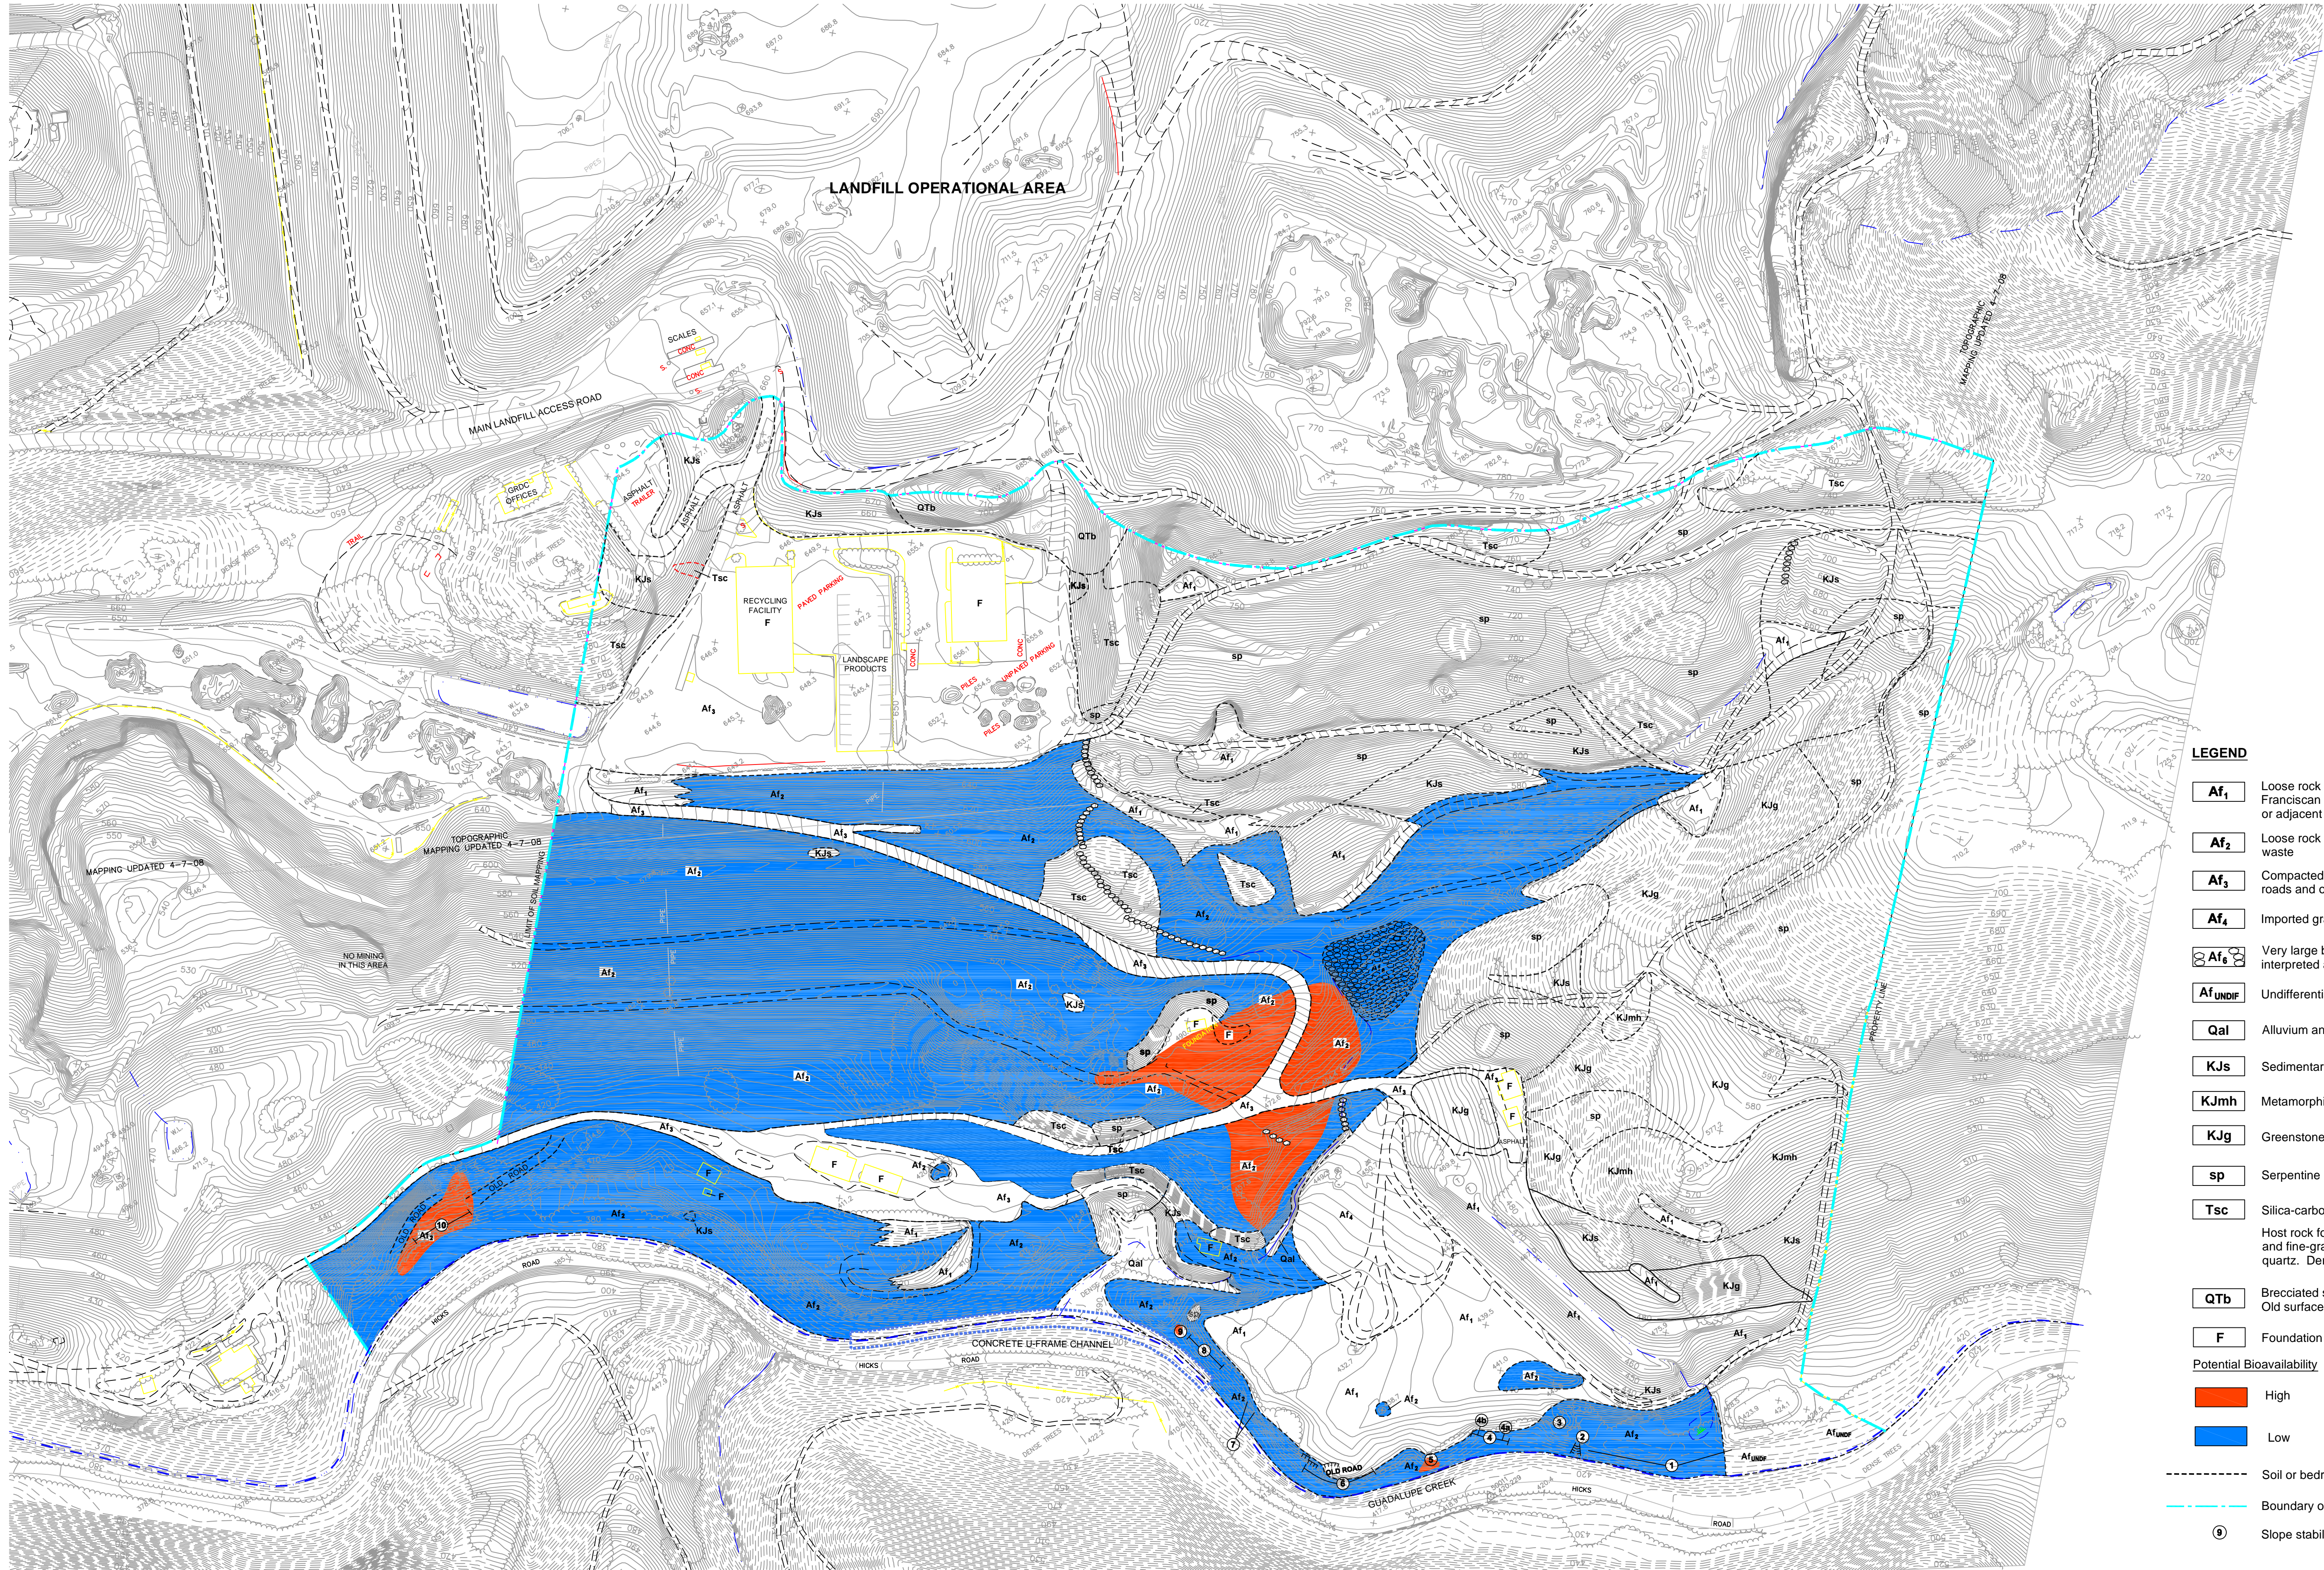
6

The potential bioavailability of mining waste, using criteria provided by Water Board staff, is shown on Figure 6. Mining waste interpreted as heat-processed ore (retort waste) was assigned the ranking of high bioavailability per the Water Board staff criteria. The most obvious exposure of retort waste is located in the southwestern portion of the mapping area, at BMP Area 10). The remains of a small concrete and brick retort structure is present below the main access road. Wooden ore chutes remain at the top of the retort structure and a wooden support for a former ore conveyor remains on the slope across the access road.

Loose fill material present at Phase 2 Areas 5 and 9 is interpreted as retort waste based on the distinctive red coloration and close association with refractory bricks.

Suspected retort waste was also identified in the south-central portion of the mapping area near a declining adit, concrete building foundations, brick pile, and other mining-related debris. This portion of the Site appears to correspond to the main processing area depicted on the USGS Plate 14. It should be noted that bioavailability is strongly linked to erosion and transport of mining waste to surface water, since methylation of inorganic mercury occurs within the aquatic environment. The processed ore located in this portion of the Site is situated a minimum of 250 feet from the Creek. Storm water runoff from this exposed mining waste is designed to be intercepted by drainage swales and directed to retention ponds or spreading areas on-Site, as specified in the SWPPP.
